# **REMEDIAL ACTION REPORT**

**AOC-24: Woodbridge Pond**

**HATCO CORPORATION SITE**

**November 2020**

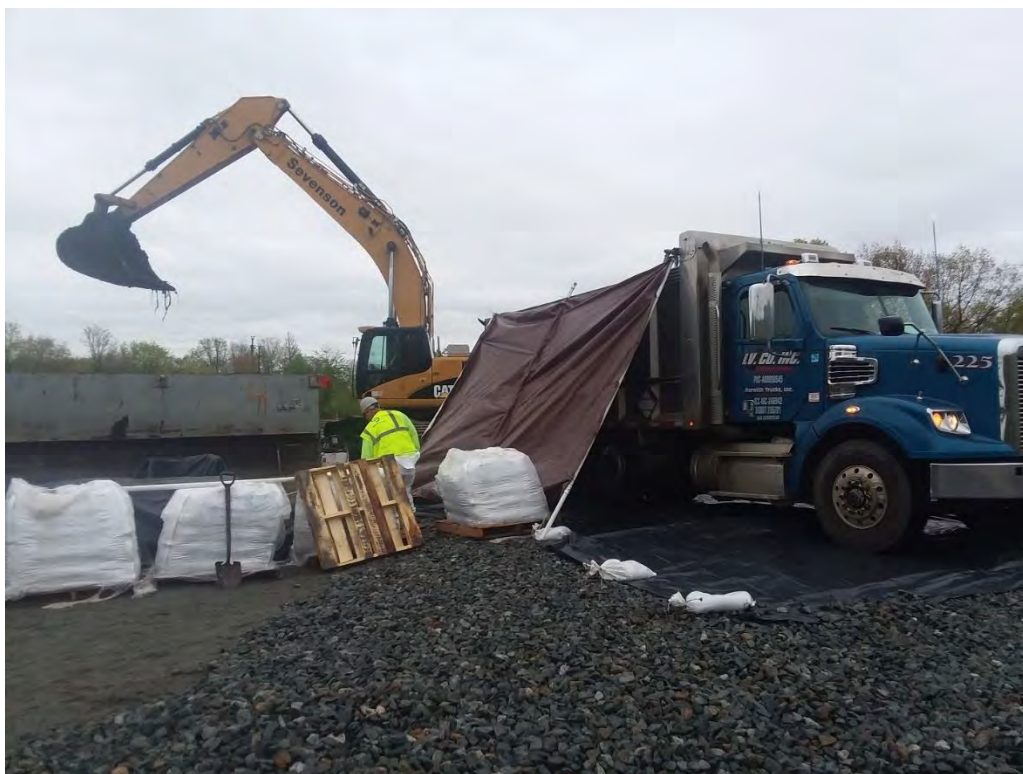
April 26, 2019. Load out of stabilized sediment for offsite disposal.

A plastic liner was spread across the truck loading area and the truck was backed into the loading area from Mac Lane. Prior to loading, each truck was inspected and separate disposable bed liners were placed into the dump body. The CAT® 345D excavator was used to place the bulk non-hazardous solid waste into each truck. After loading, the truck was prepared for travel by covering the load in the dump body and pressure washing the tires to remove incidental materials. After the truck exited the loading area, wastewater was collected from the plastic liner. The plastic liner was then rolled and stored pending the next load. Minor amounts of stone dust were occasionally tracked into the street by the dump trucks. The dust came from the clean stone cover located between the truck loading area and curb line. The tracked stone dust was swept and removed by SES.

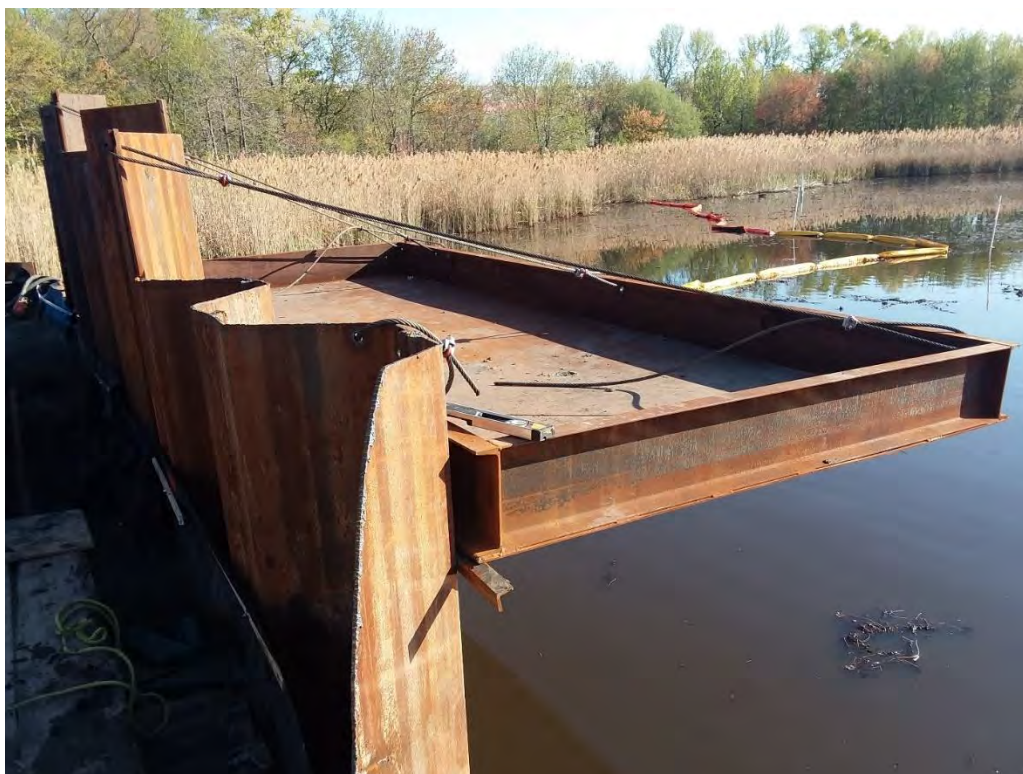
April 29, 2019. Drip pan at bulkhead offloading area.

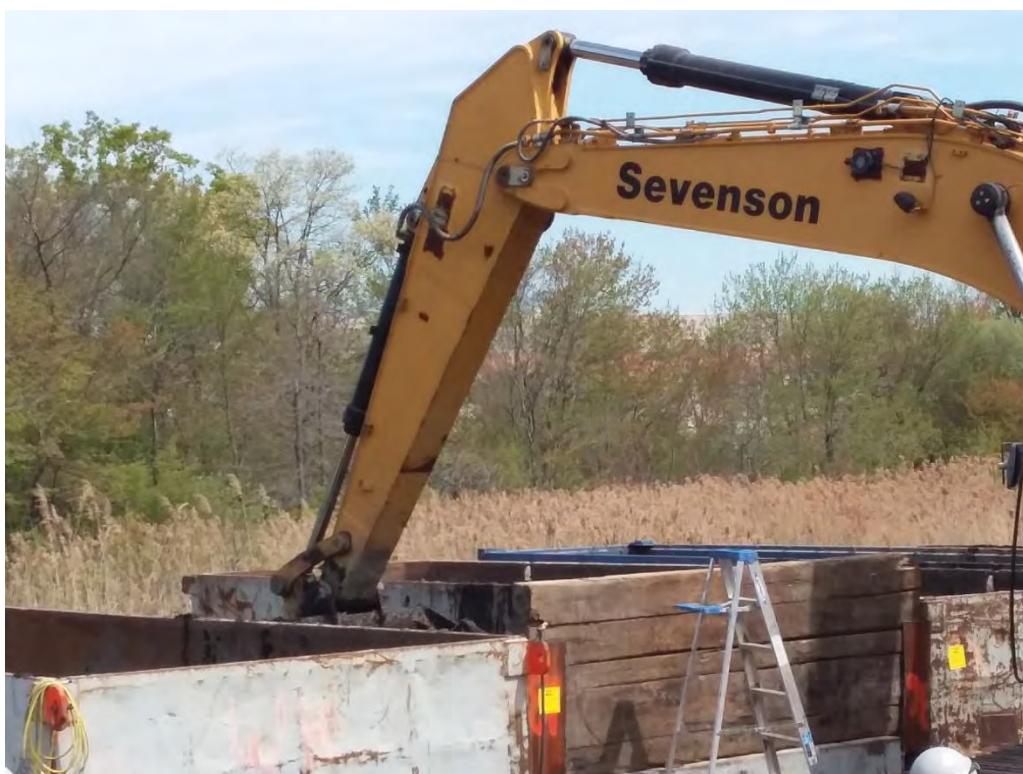
April 29, 2019. Sediment stabilization in steel hoppers

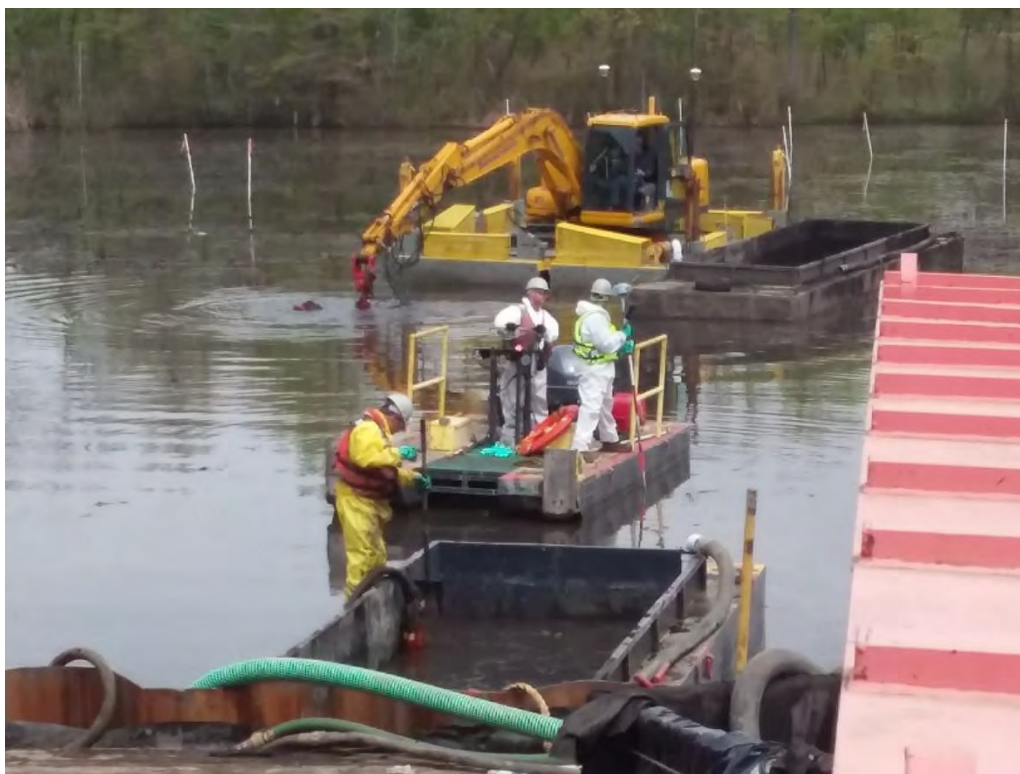
April 30, 2019. Dredging and survey activities.

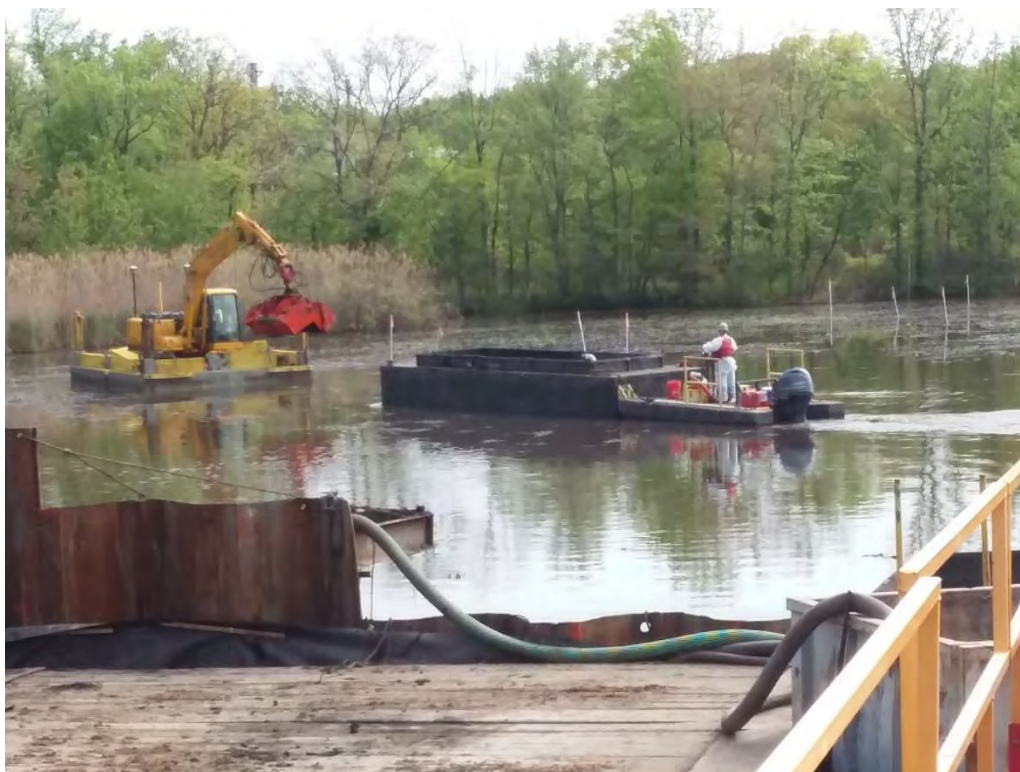
May 7, 2019. Dredging operations: Push-boat locating scow to be filled by dredge.

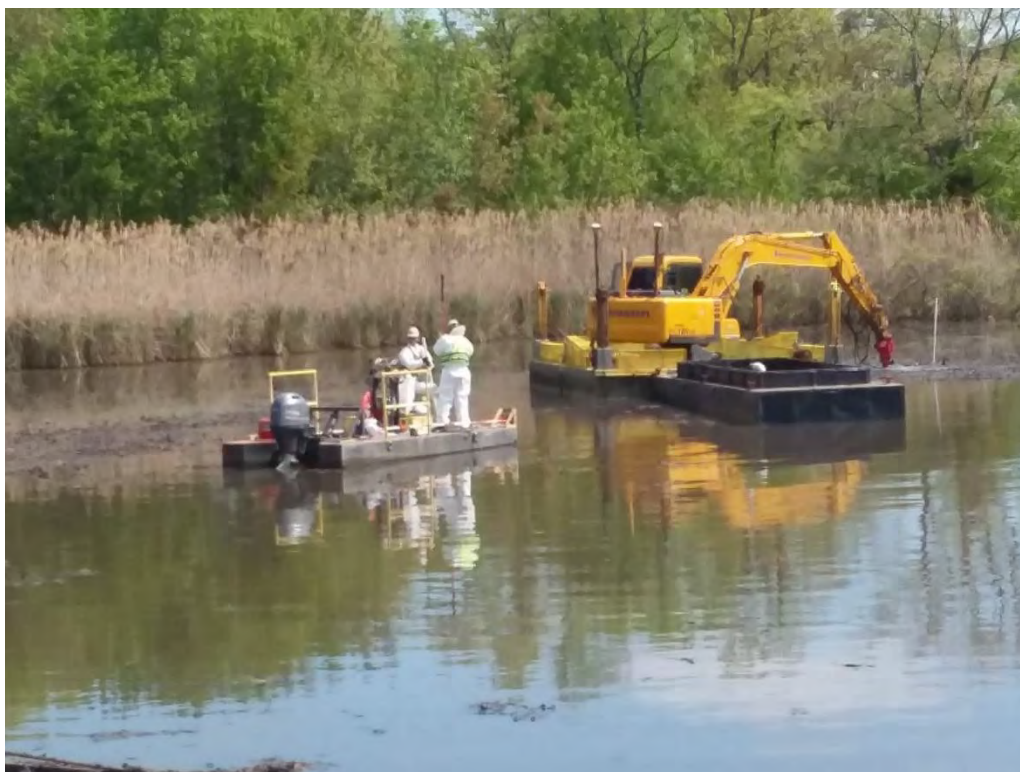
May 7, 2019. Collecting post-excavation verification samples.

The SES sampling technician collected the verification samples using an AMS, Inc. Multi-Stage Sludge/Sediment stainless-steel sample coring device equipped with dedicated, disposable transparent polyethylene liners.

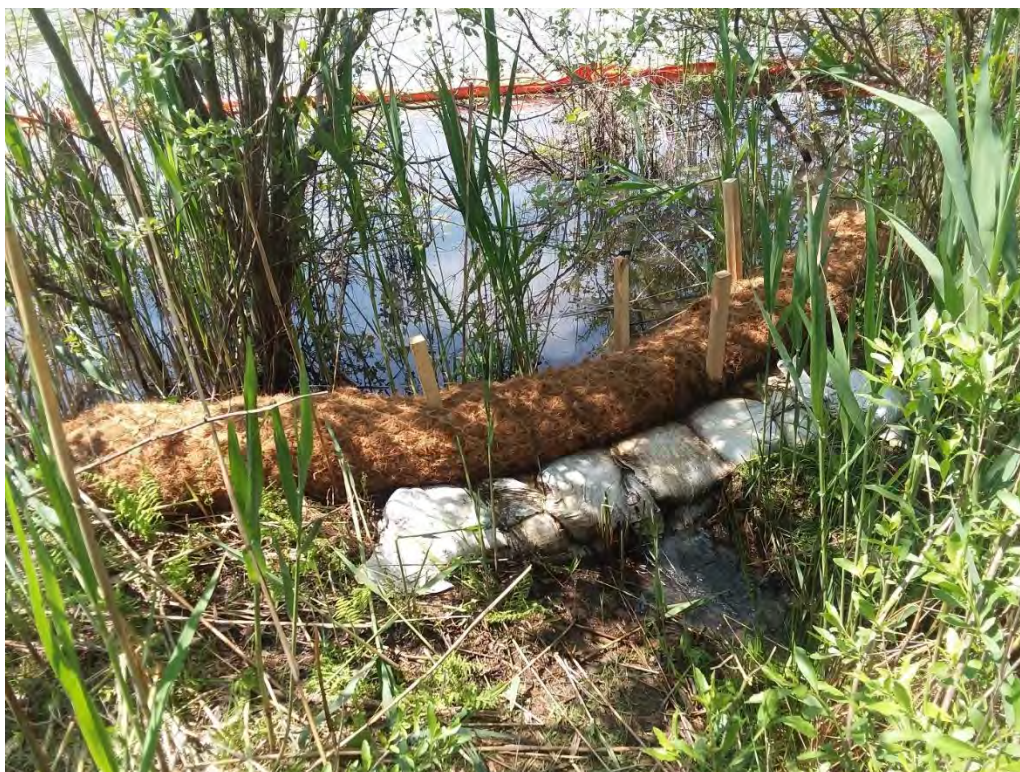
May 8, 2019. Temporary weir and sedimentation controls installed at pond outfall

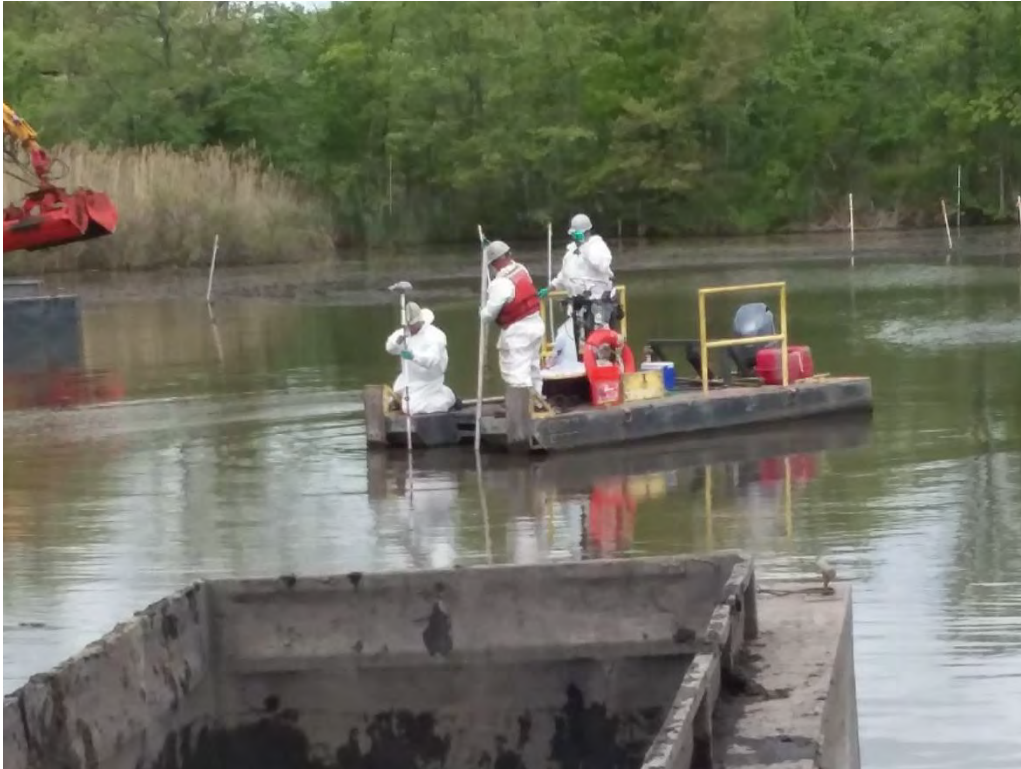
May 10, 2019. Surveying post-excavation bottom elevation

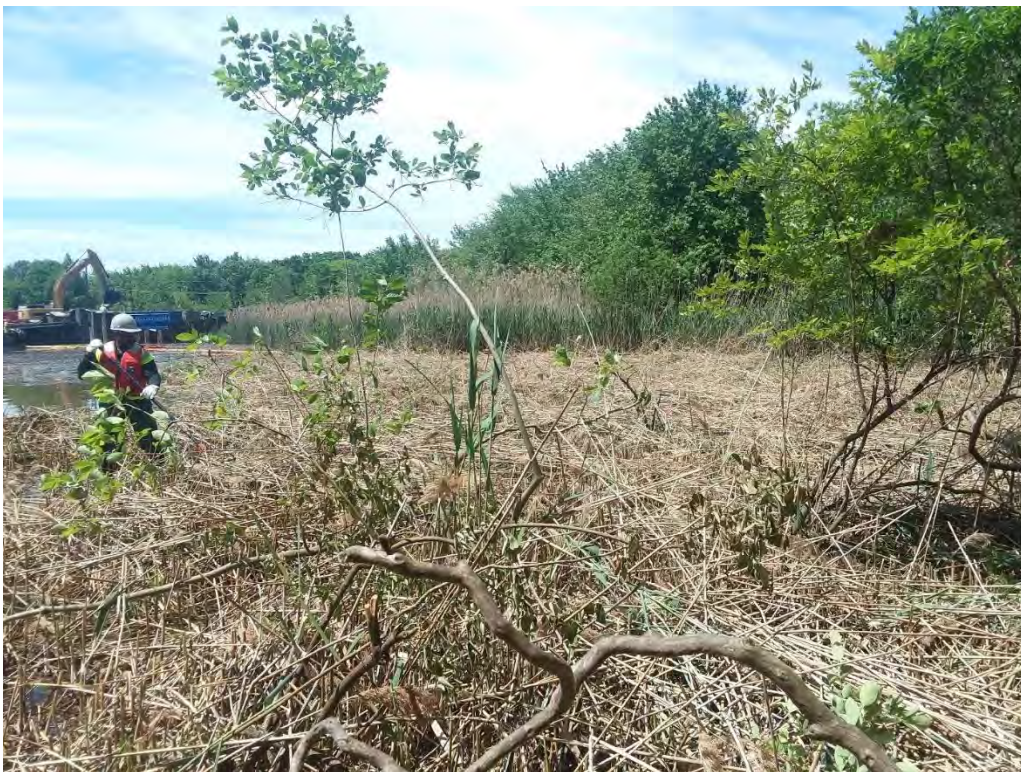
May 21, 2019. Initial clearing of vegetation from planned wetland enhancement area

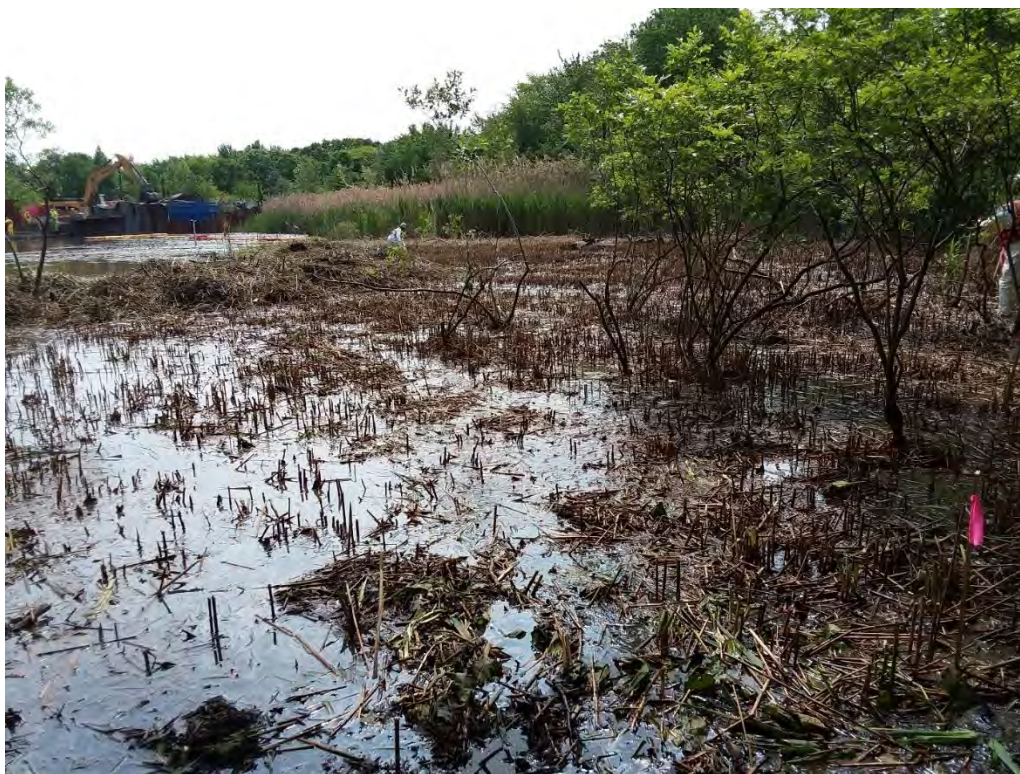
May 23, 2019. Open water in footprint of planned wetland enhancement area.

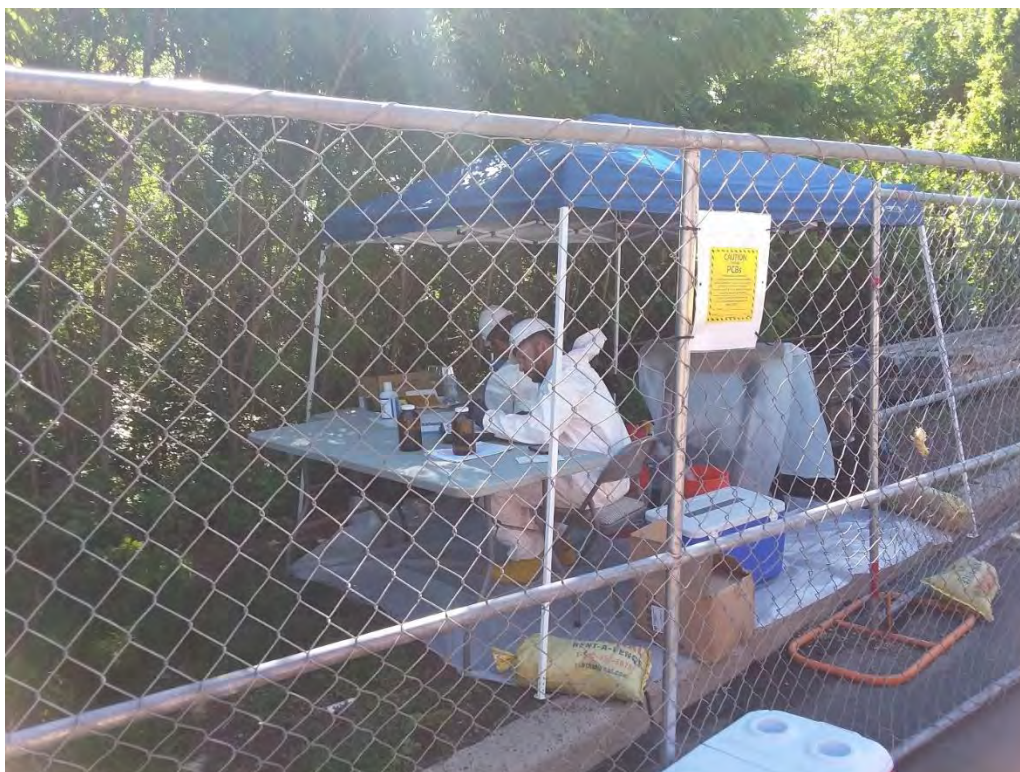
May 24, 2019. Sediment sample processing and collection.

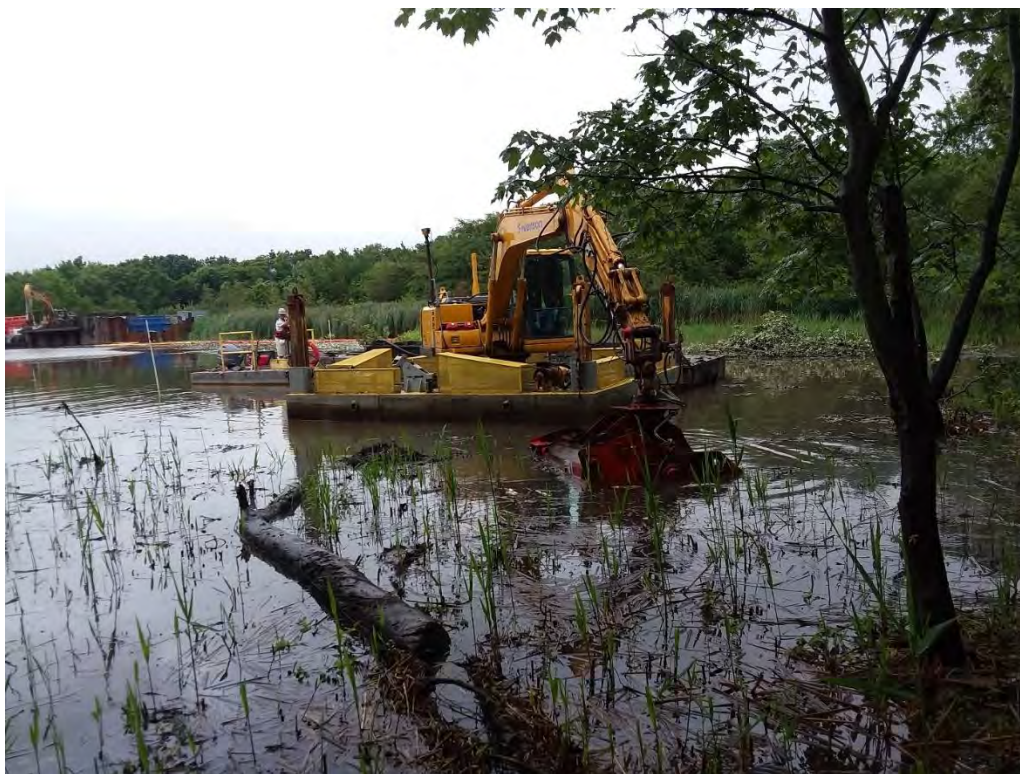
June 19, 2019. Dredging within planned wetland enhancement area.

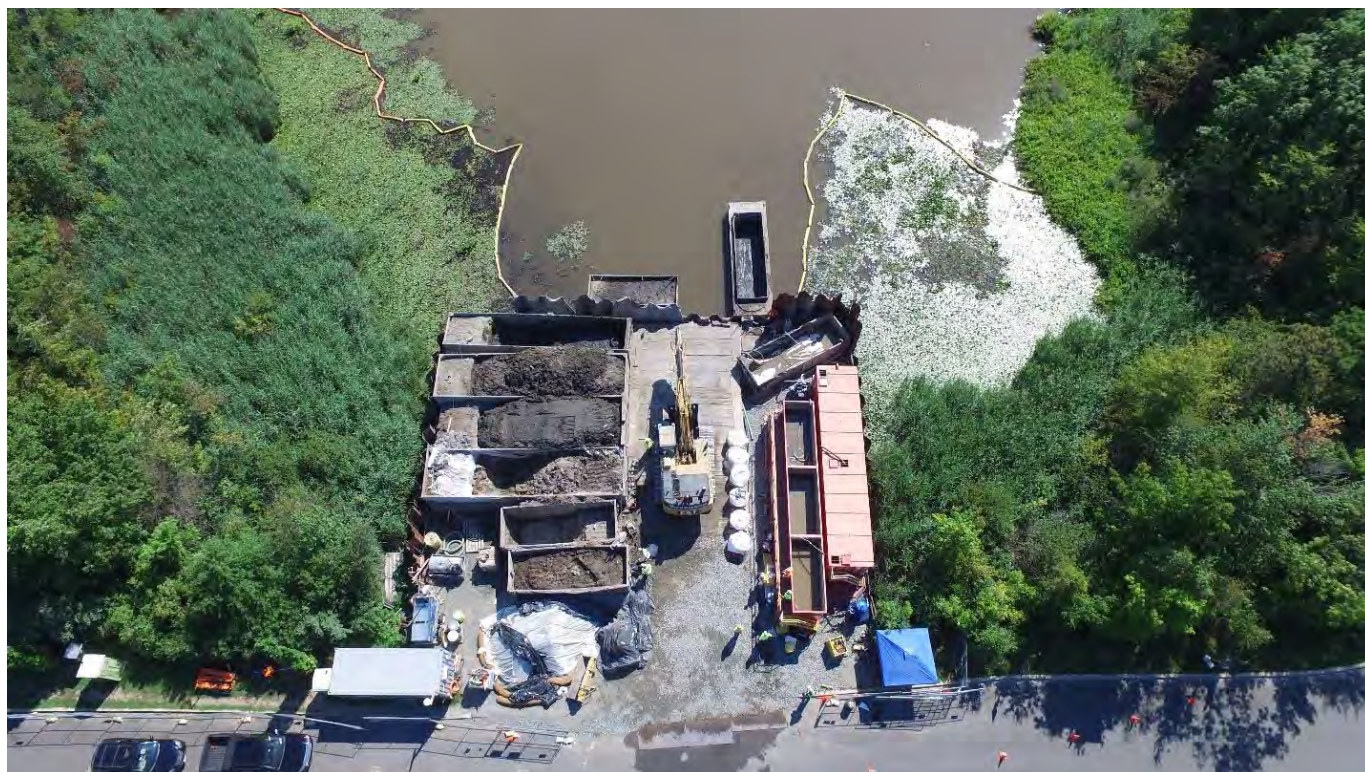
July 16, 2019. Aerial view of temporary staging and processing area operations

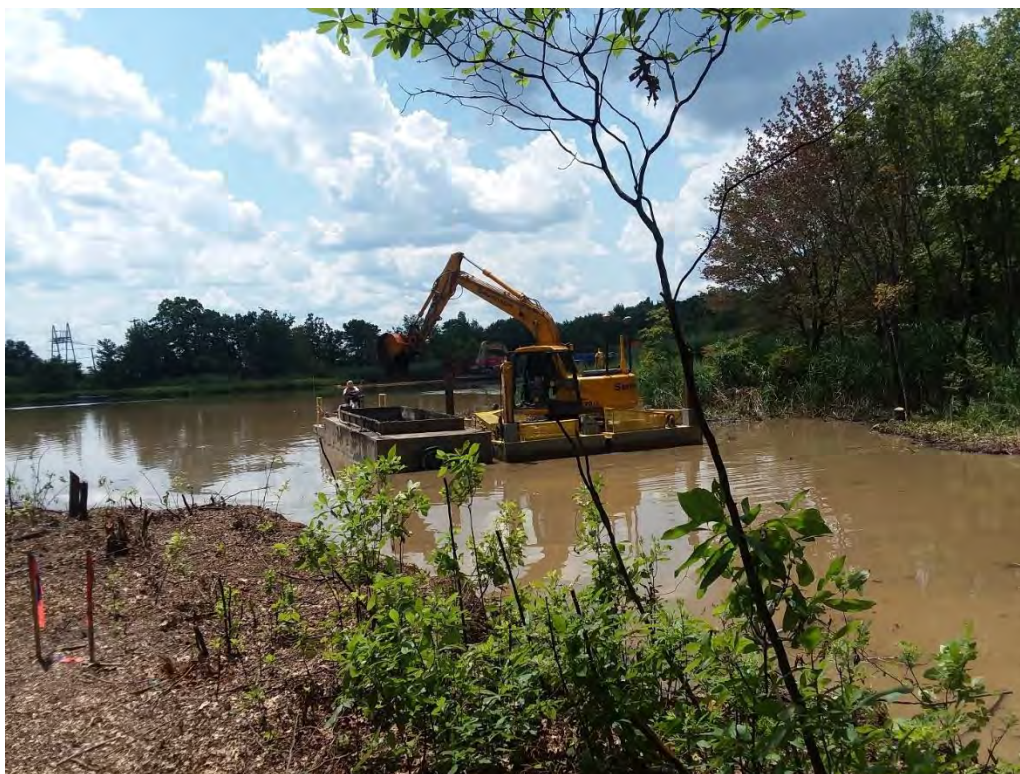
July 25, 2019. Dredging of wetland area north of planned wetland enhancement area

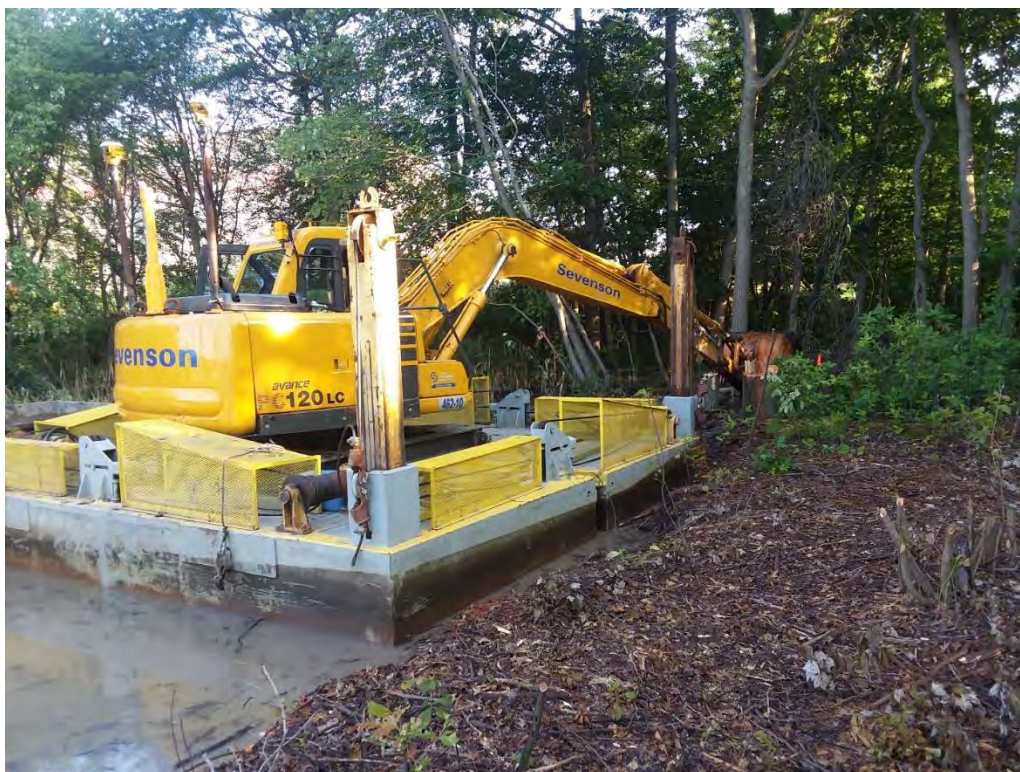
July 25, 2019. Northern extent of wetland dredging

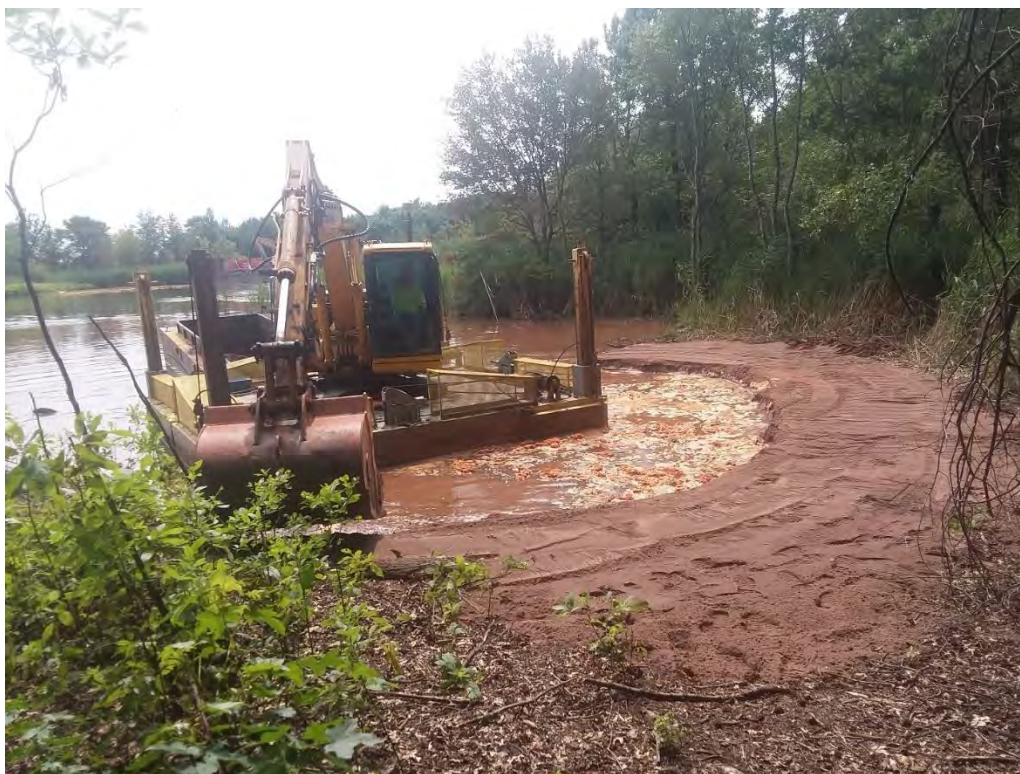
August 5, 2019. Wetland backfilling

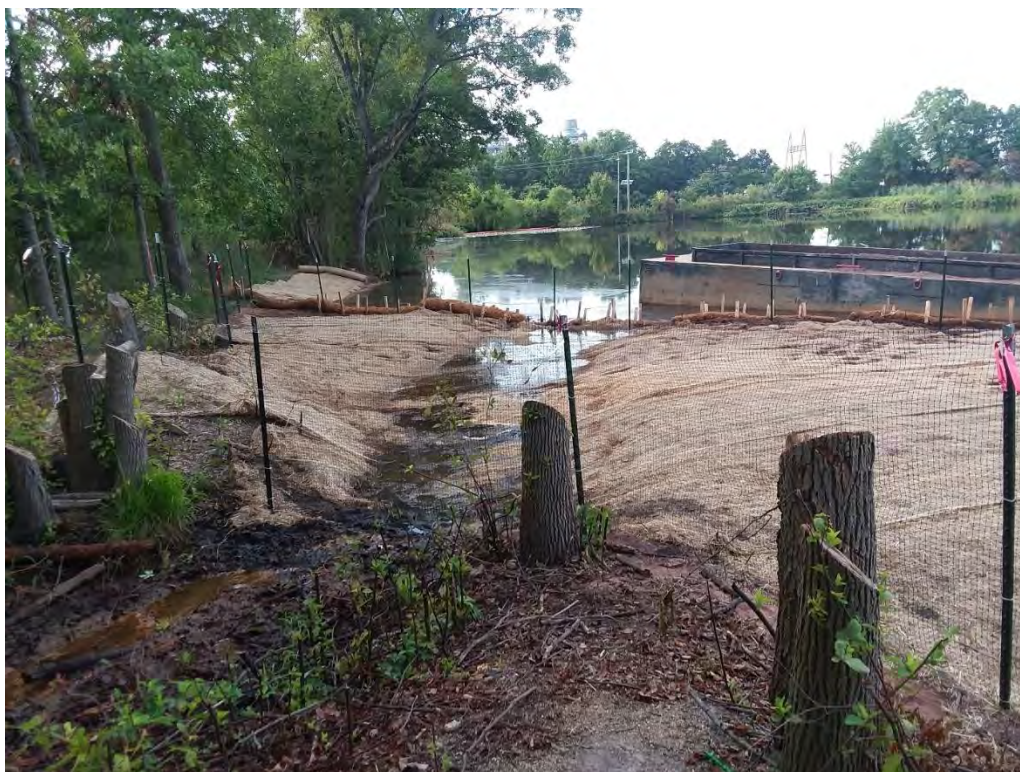
August 22, 2019. Restoration of wetland north of pond

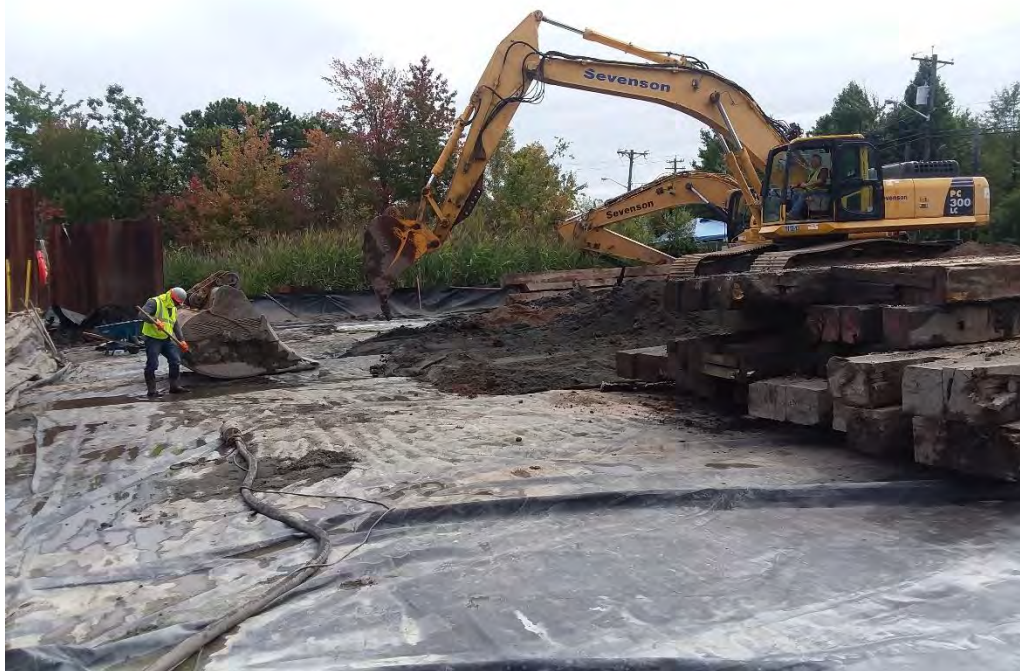
August 27, 2019. Removal of sand fill and timber mats from above protective liner in temporary processing and staging area

On August 26 and 27, 2019, the upper two feet of fill material were removed for offsite disposal and the protective liner was exposed. The liner was inspected and no damage was observed. Samples were collected to confirm that the clean fill material beneath the protective liner had not been affected by remediation activities. Samples were collected, analyzed and determined to be suitable for backfill as discussed in Section 5.3.2.

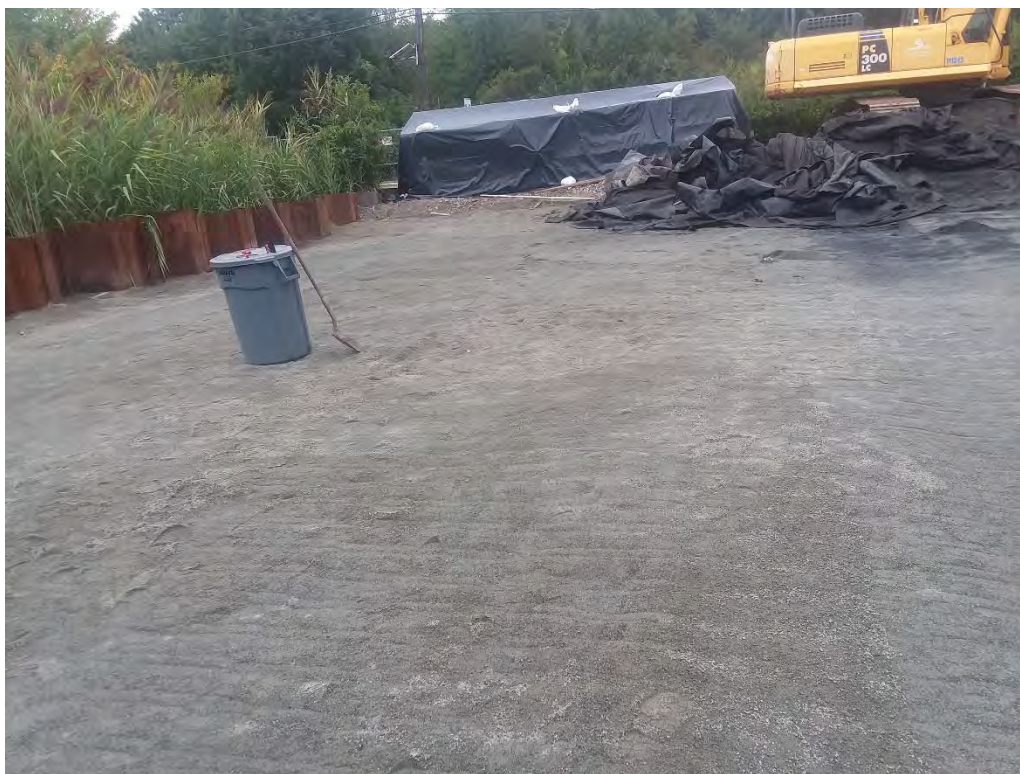
August 28, 2019. Removal of protective liner from temporary processing and staging area

On August 28, 2019, the liner was removed and the clean fill inspected. No evidence of spills or contamination was observed.

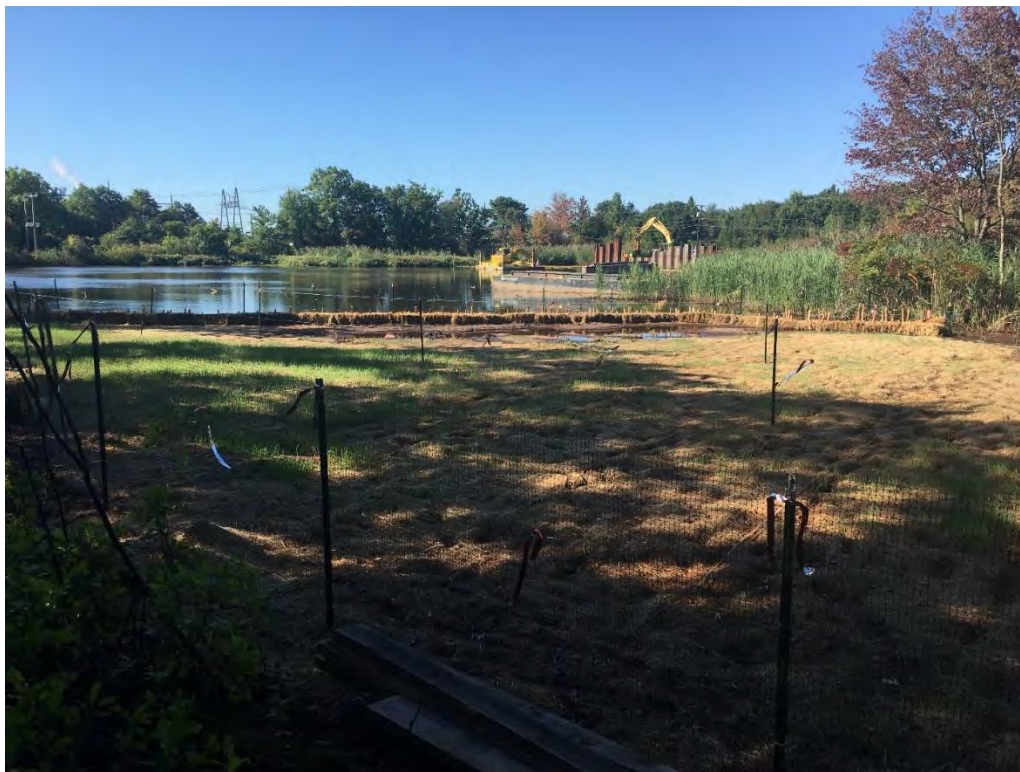
August 29, 2019. Wetland restoration area north of pond.

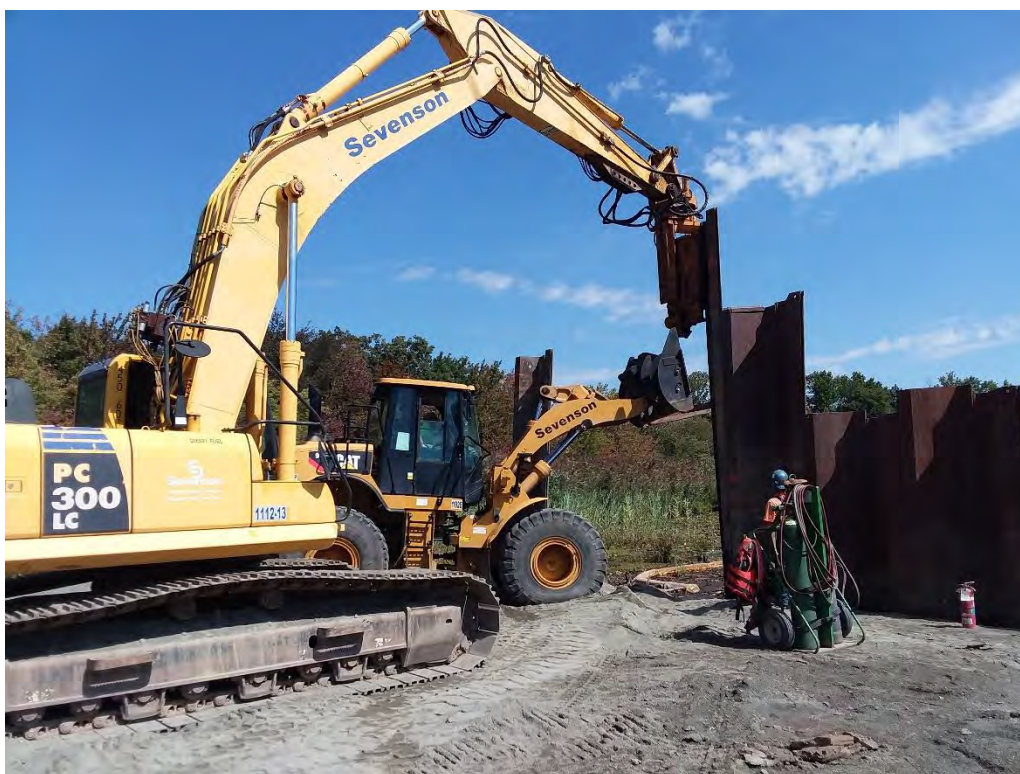
August 30, 2019. Removal of sheet piling from temporary staging and processing area

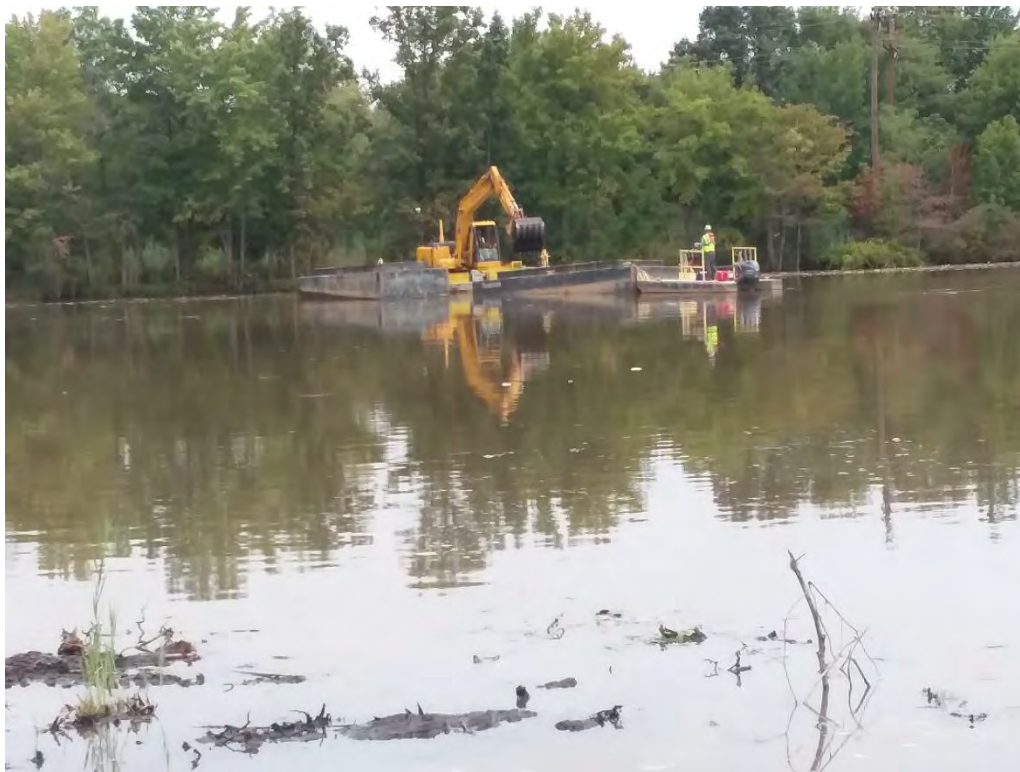
September 5, 2019. Placement of clean backfill in deep dredge areas

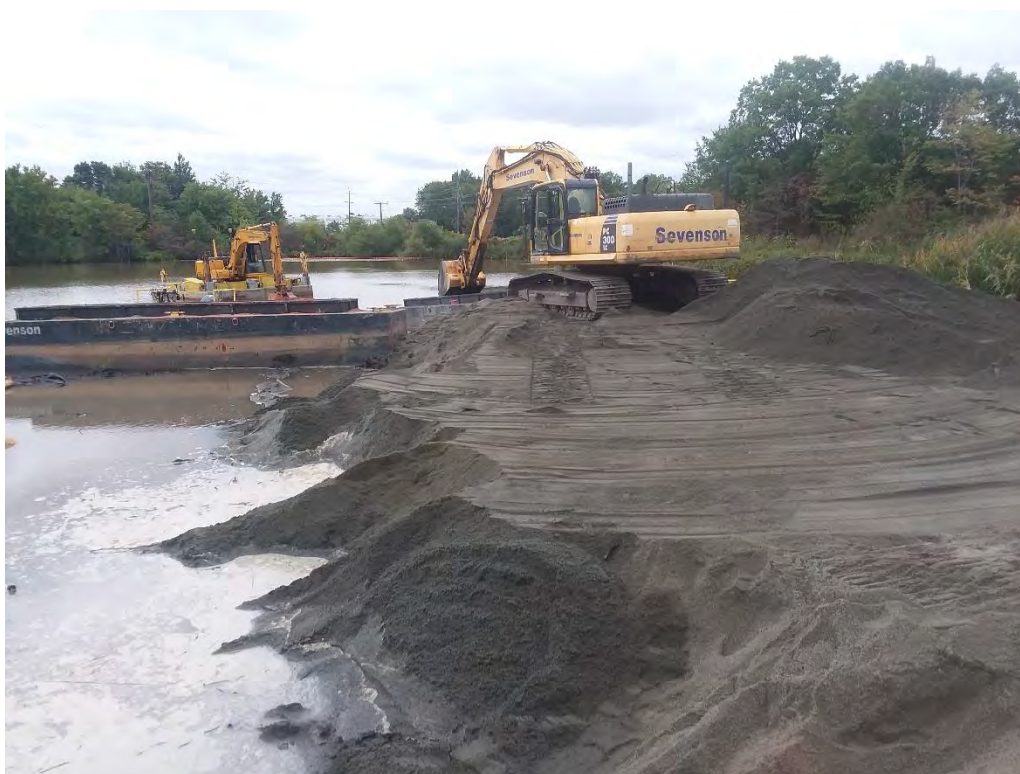
September 6, 2019. Removal of clean sand from temporary staging and processing area for placement in deep dredge areas.

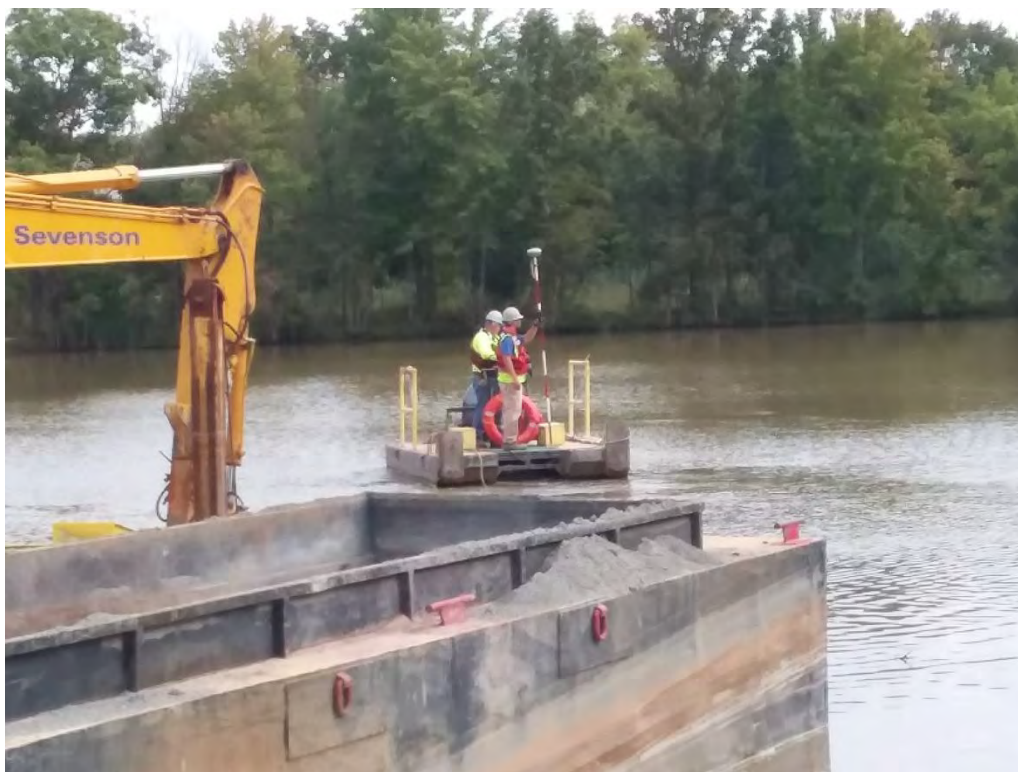
September 9, 2019. Final survey of pond bottom

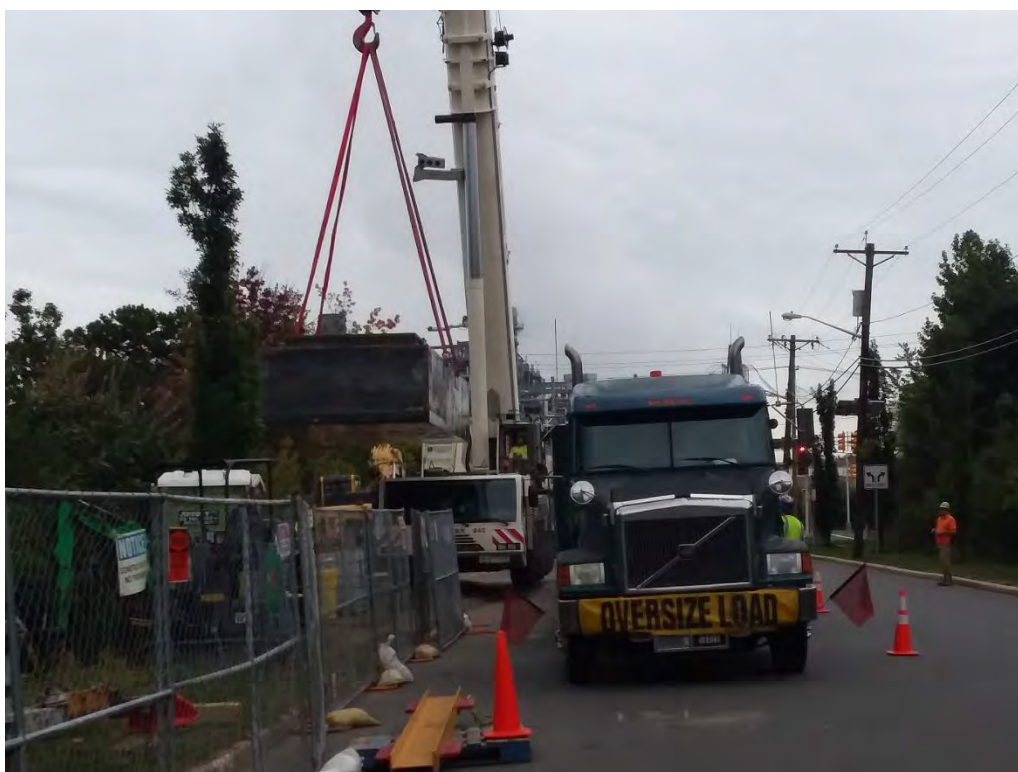
September 10, 2019. Equipment demobilization

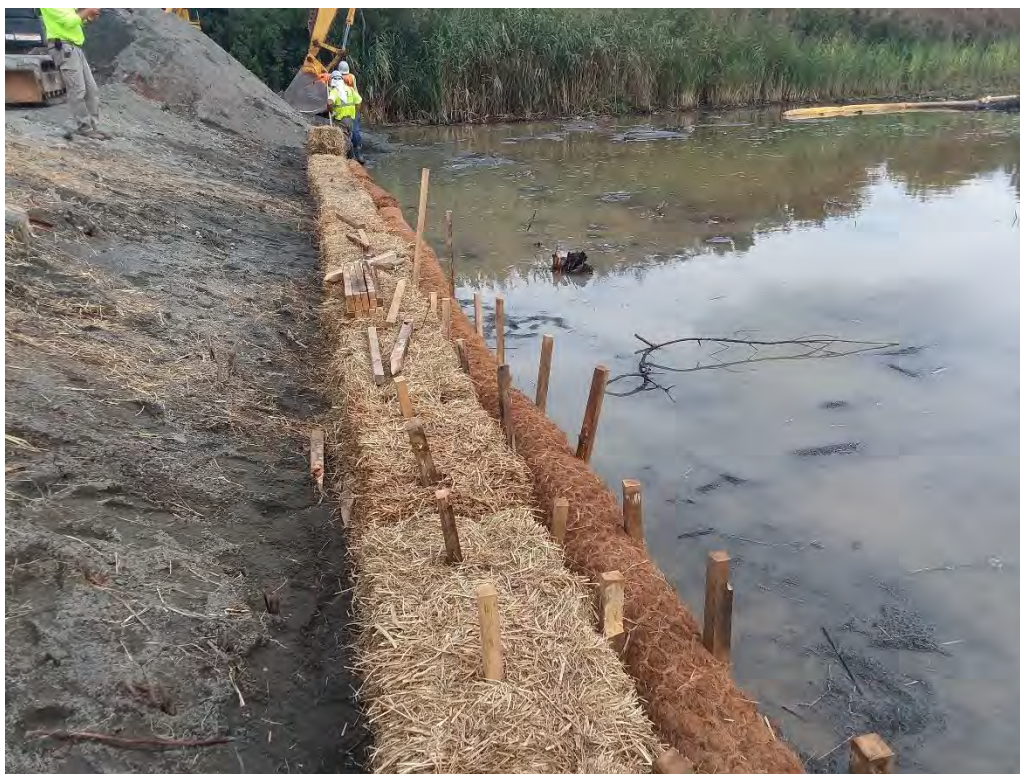
September 12, 2019. Installation of coir logs at base of wetland restoration along Mac Lane

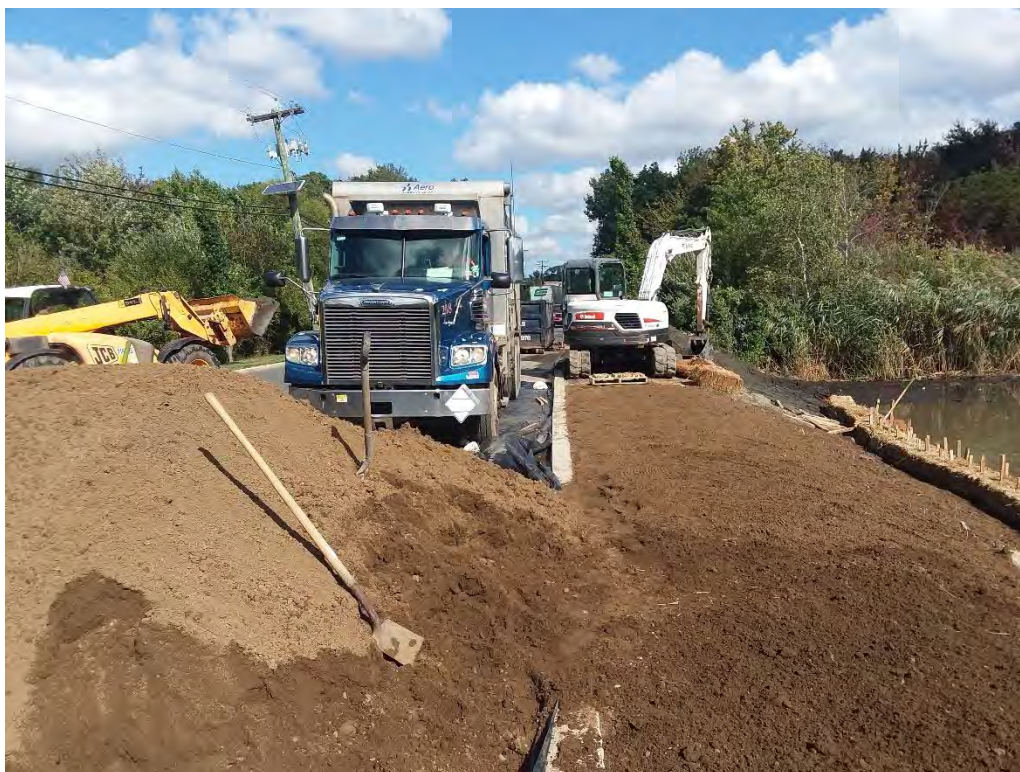
September 13, 2019. Placement of topsoil in wetland restoration area along Mac Lane

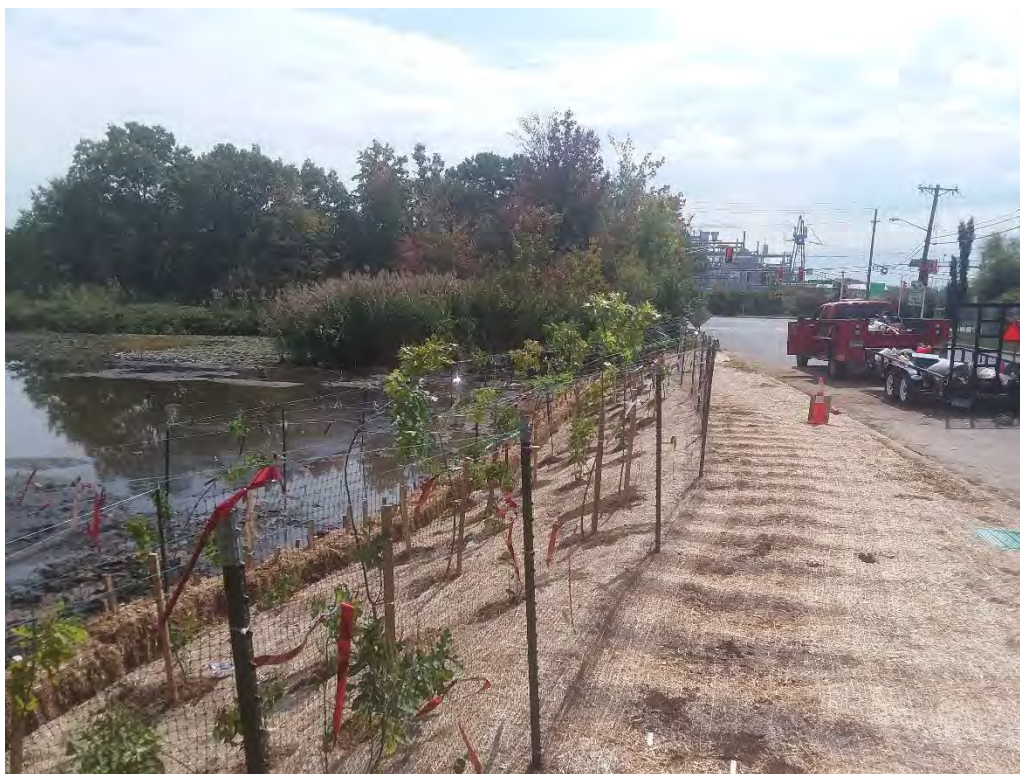
September 16, 2019. Installation of plantings in wetland restoration area along Mac Lane
